### Tensile properties

Customer : Nedex  
 Project no. : 89211xxx  
 Tester : MSS  
 Test standard : EN 1279-4 H sample  
 Specimen ID : 17.A071  
 Material :  
 Pre-treatment : after 96 h UV

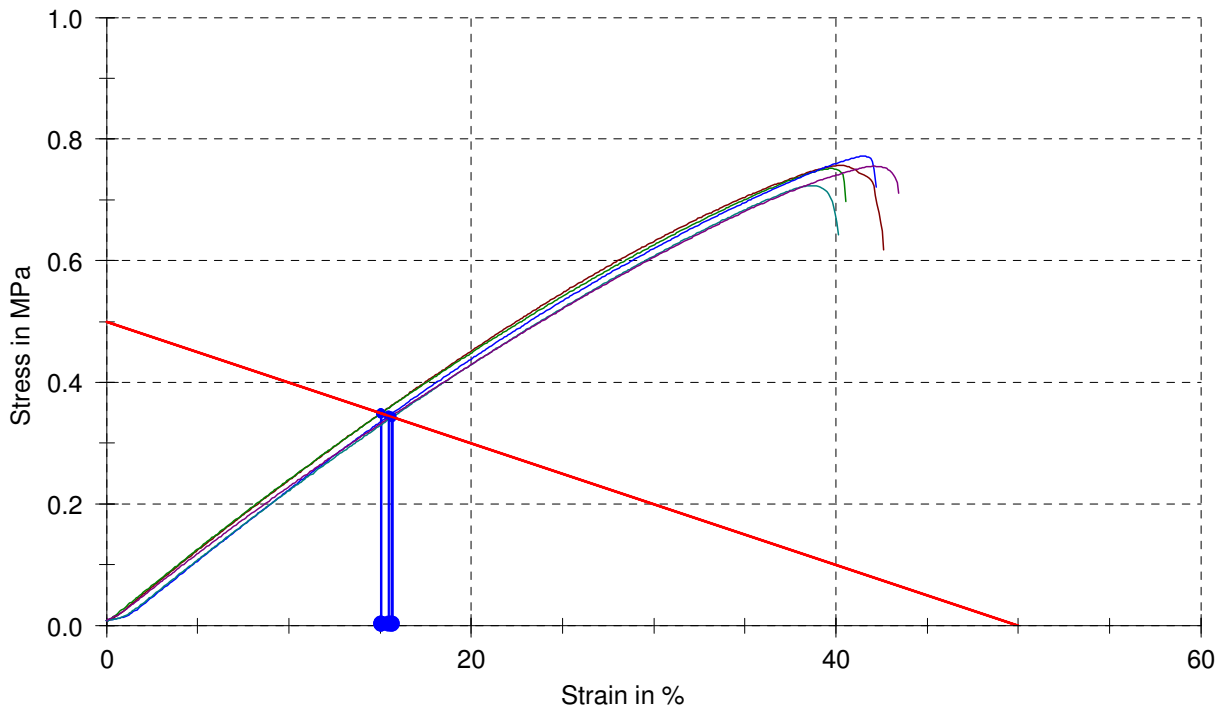
### Curves

Conditions : 23°C / 50 % RH  
 Extensometer (path) : cross head  
 Specimen grips : H-sample  
 Pre-load : 5 N  
 Test speed : 5 mm/min  
 Load cell : 20kN

Series	width b0 mm	thickness a0 mm	A mm <sup>2</sup>	Kit height mm	σ-max MPa	ε Break %	σ c MPa	ε c %
n = 5								
$\bar{x}$	51.5	12.4	636.8	12.2	0.75	42	0.346	15.4
s	0.4	0.1	5.9	0.0	0.02	1	0.003	0.3
v	0.74	0.44	0.93	0.00	2.32	3.35	0.88	1.97
